service reference book
session no. 105

POWERFLITE,

POWER STEERING

BRAKE SERVICE

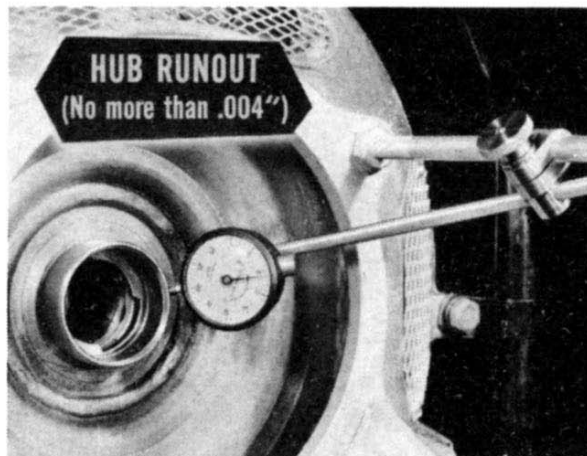
rod in the converter housing, and place the anvil of the indicator on the hub. Turn the converter one complete revolution two or three times, and watch the indicator. Hub runout shouldn't be more than four thousandths. If it is, drain the converter. Then, mark the low spot and turn the converter until the mark is directly down. Use an acetylene torch with a No. 3 tip set at maximum heat to heat the front of the converter. Do this through the opening in the adapter plate.

Usually, you'll heat a spot about $\frac{1}{2}$ " in diameter until it is a dull red. Next, quench the area quickly with wet rags to shrink the hub back into line. Recheck hub runout with the dial indicator when the converter returns to a uniform room temperature.

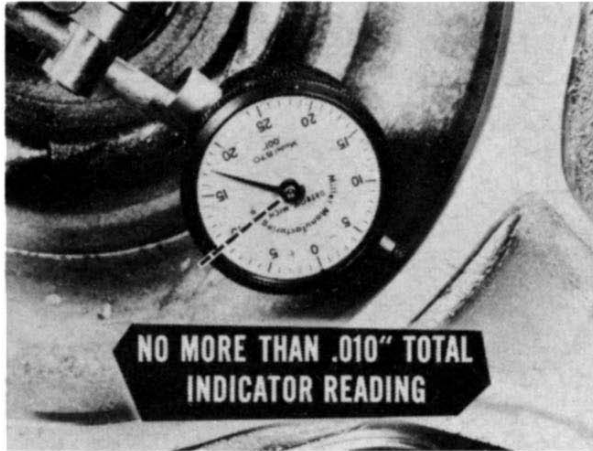
your readings. There should be no more than .010" *total* indicator reading. If it is more . . . say about .018" total reading, you'll have to shift the housing on the adapter plate in a direction opposite the point you noticed the maximum runout indication. Shifting the housing is done by first replacing the two steel dowels.

When selecting the new eccentric dowel to be used for a particular job, take the dowel closest to *one-half the total indicator reading*. For example:

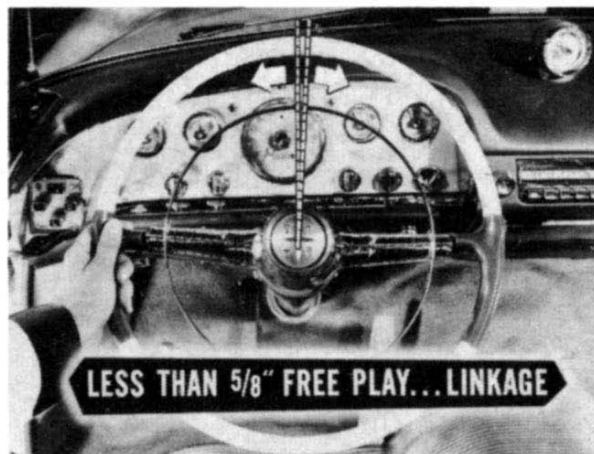
For example . . . if there's *less than 5/8"* free play at the steering wheel with the engine running . . . and you know the car wanders, the linkage is either loose or binding somewhere.

On the other hand, if free play at the steering wheel rim is *more than 5/8"*, *without moving the linkage*, the power unit is at fault.

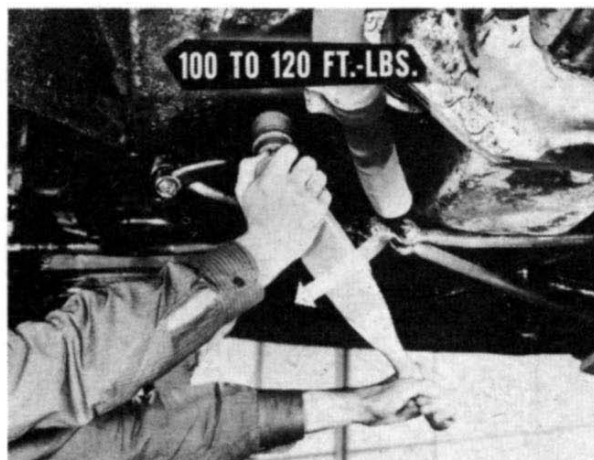
Check the Linkage—To check the linkage, raise the car. Then, visually—and by “feel”—check the entire linkage system. Look for looseness. The steering gear arm, for instance, should be tight on the gear shaft. If it isn't, tighten the nut 100 to 120 foot-pounds.

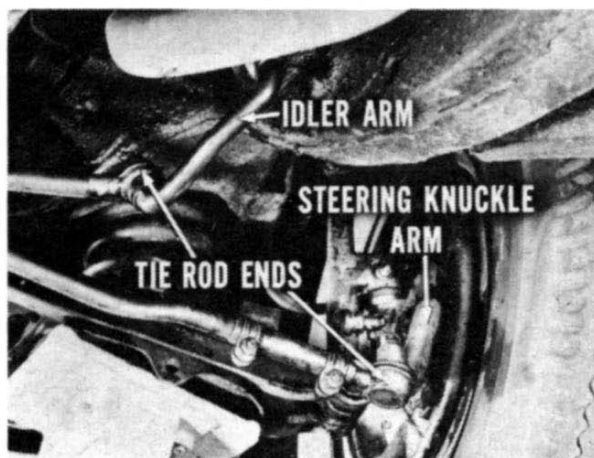
Check also for a bind or looseness at the idler arm. Besides that, look for loose or cocked tie rod ends . . . or loose steering knuckle arms. Tighten or replace any faulty parts.

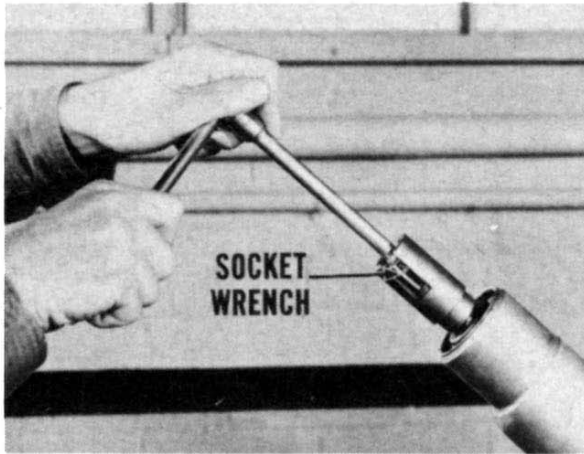
Check the steering worm coupling screw next. If it had worked loose, there would be too much backlash in the tube and coupling. In this case all you have to do is use a socket wrench and make sure the screw is snugged down good and tight.

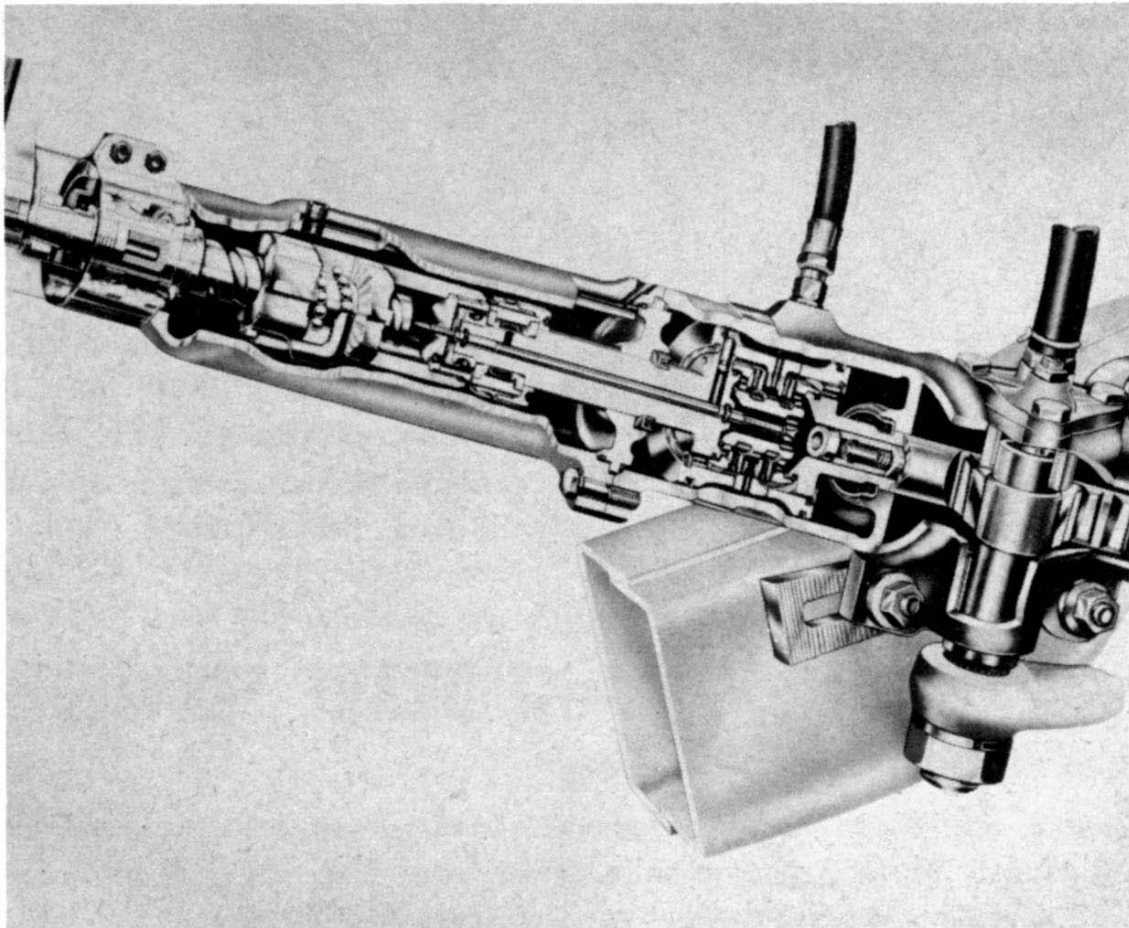
Now, while the power unit is pressurized, if high pressure leaks are present, you'll notice them at one of the following locations:

- (1) At the upper piston rod, indicating that this seal is in need of replacement.
- (2) At the upper end of the valve rod, which means the "O" ring seal in the upper end of the upper piston needs replacement.
- (3) At the reaction seal retainer, which points to replacing the reaction control seal.
- (4) At the housing cylinder head, which may show up a fine crack due to incorrect disassembly procedure or a casting that's become porous.

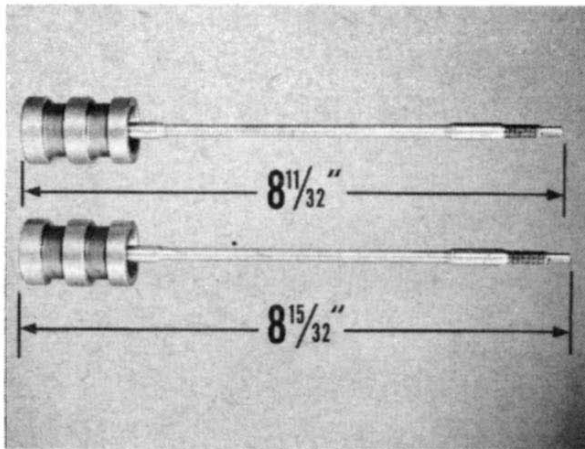
has been *forced out of its groove* at the upper end of the upper piston rod, chances are that the valve rod is too short. So, *check the length* of the rod. The short rod is $8\frac{11}{32}$ " long. The long rod is $8\frac{15}{32}$ " long. If necessary, replace the piston valve and rod assembly to correct this condition.

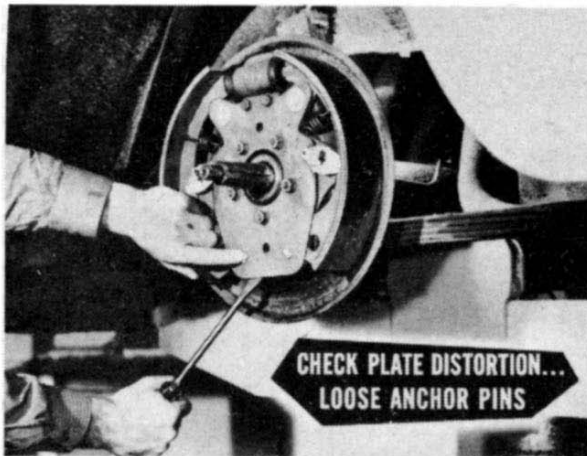
Next, inspect the support plates for distortion, and for loose anchor pins. Use a screwdriver between the plates while you press a finger against the end of the anchor pin to check looseness.

If the pins are loose, remove the support plate from the dust shield. Rest the pin on an anvil, and peen the end until the pin is tight. Be sure that both support plates are in good alignment.
