**THE MASTER TECHNICIAN'S  
SERVICE REFERENCE BOOK**

**63-9**

**SERVICING**

**MASTER TECHNICIANS SERVICE CONFERENCE  
PREPARED BY CHRYSLER CORPORATION  
PLYMOUTH • DODGE • CHRYSLER • IMPERIAL**

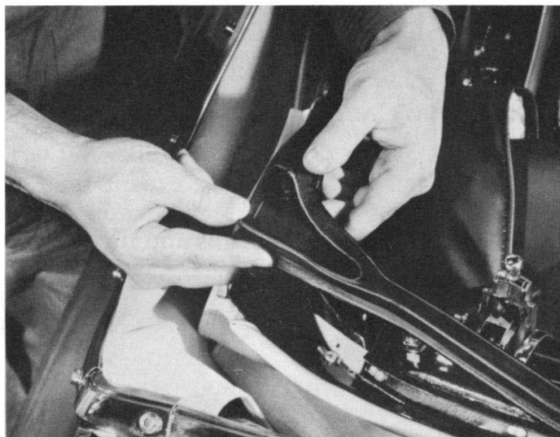
Fig. 11—Check weatherstrip for distortion

On Valiant and Dart models, first lower the top and fold it back into the top well. Then, remove the small curved black metal weatherstrip retainer and screws at each corner of the header and discard them. If the weatherstrip shows signs of distortion in this area due to the retainer, discard it. The weatherstrip cannot be reshaped to provide an effective seal.

Next, punch a three-sixteenths-inch hole at each corner of the weatherstrip, midway between the two corner retainer screw holes. Also, drill a number twenty-eight hole in the top material retainer, at each corner, in line with the punched hole in the weatherstrip.

Then, remove the weatherstrip retainer and the top material retainers from the top header and discard the screws. New, longer screws will be used when the retainers are reinstalled.

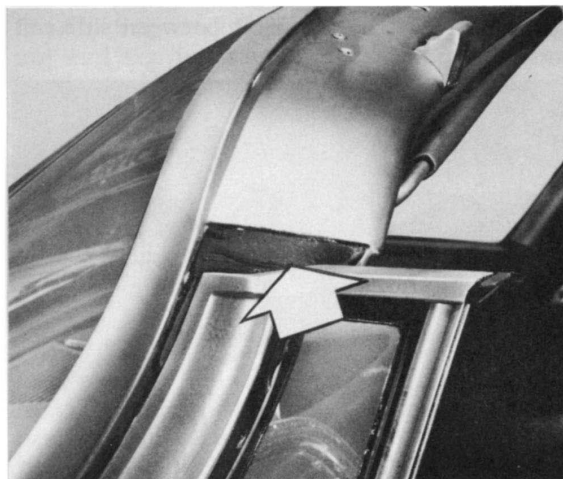
Fig. 17—Check vent wing seal condition

Water leaks at the top header on Dodge 880 and Chrysler models can be corrected by following the instructions as outlined. Latch the top down securely and close the door. From the inside of the car, check for a possible leak at the pillar-to-vent-wing seal. Look for water traces or light anywhere along the top edge of the vent wing frame.

If you see an opening, check the condition of the seal from outside the car. If there is a leak, it may be that the sealing lip of the roof rail weatherstrip doesn't seal properly along the top edge of the vent frame. It is possible, in some cases, for water to leak in even where there seems to be no visible evidence of a leak.

It may be necessary to either shim or trim off the top of the seal to get a good sealing lip along the top edge of the vent frame. When reinstalling the seal, be sure to clean the surface thoroughly of all old cement with a solvent. Also, clean the seal to remove any mold powder. Apply cement to the windshield pillar and the seal. Let it dry tacky, then press the seal into place. In some cases, if the old seal is damaged, it may be necessary to install a new seal to stop a leak at the upper edge of the vent wing frame.

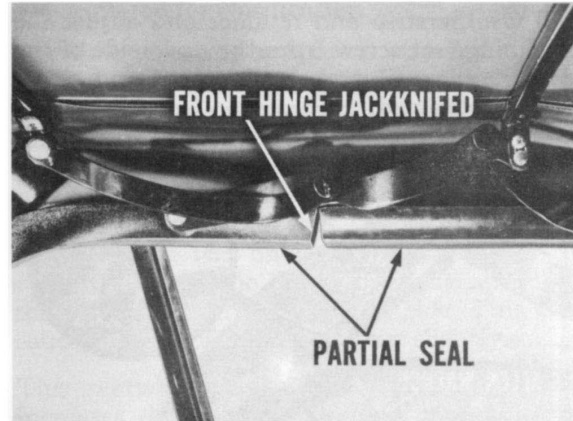
Fig. 20—Front hinge jackknifed

Water and/or air leaks between the top and door or quarter glass might be due to poor contact between the roof side rail weatherstrip and the glass or only a partial contact between the roof rails and the top edge of the glass. If examination shows that the leakage is due to

a jackknifed condition at the hinge, it will be necessary to adjust the hinge set screw to close the joint.

If the front hinge is jackknifed, use a one-eighth-inch Allen wrench and turn the set screw in a counterclockwise direction to close the joint until the front and center rails are parallel. Fasten the top temporarily to check parallelism and alignment with the door glass. Readjust the set screw, if necessary.

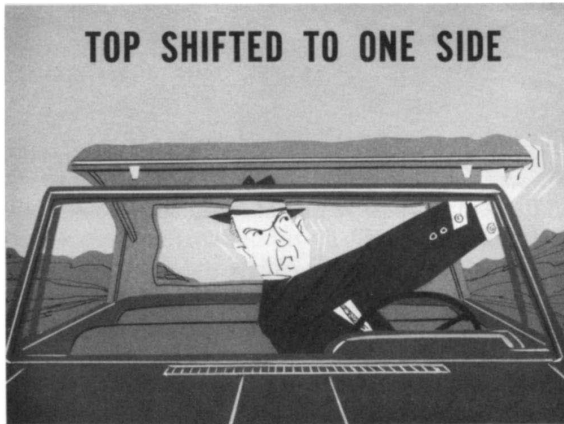
Fig. 25—Prop link bracket misadjusted

If a customer reports that it is necessary to pull the top to one side to engage the locating dowels in their sockets in the windshield header

or that the top shifts to one side when he raises the header from the windshield header, check the main prop link bracket adjustments. It is possible the brackets are not adjusted uniformly, which changes the operating angle of the linkage, causing the top to twist when it is raised.

This possibility makes it extremely important when one bracket is adjusted to be sure that the position of the bracket on the opposite side be checked and adjusted, if necessary.

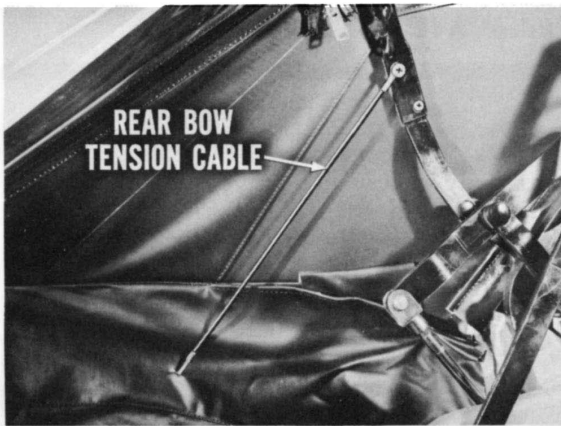
Fig. 31—Rear bow tension cable

Wrinkles in the top material indicate one of two conditions. Either there is insufficient tension on both cables or cable tension is unequal. In either case, by adjusting the cables according to the dimensions applicable to the model car being worked on, the top material can be made more presentable. Before attempting to adjust the cables, unfasten the top header latches to relieve tension on the linkage.

On the inside of the car, locate the centerline of the top on the rear bow and the ledge of the top well. From the centerline, measure the specified distances each side of the centerline at the bow and the ledge. These are locating points for backlight depth dimensions that govern the cable tension.

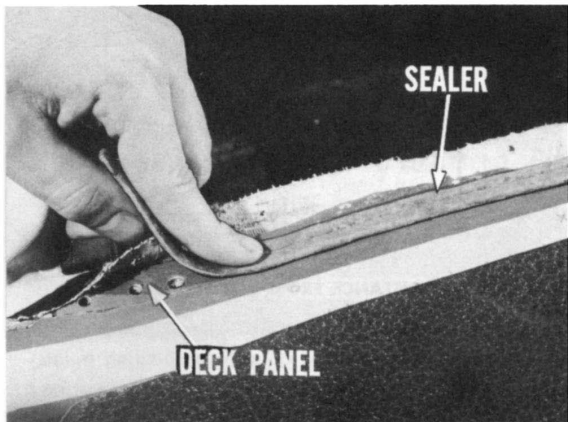
Fig. 34—Install body sealer on deck panel

If a customer reports water leaking into the top well, it may be entering between the lower edge of the backlight and the deck opening upper panel.

The leak can be corrected by sealing the area with body sealer and a polyethylene foam seal. First, apply a strip of masking tape on the deck panel directly to the rear of the finish molding to facilitate the installation of the retainer and molding screws.

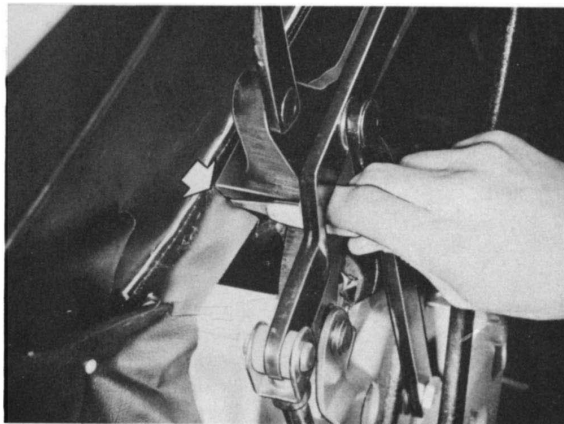
Fig. 37—Slit lower flap to install seal

It has been reported on some early-model

Plymouth and Dodge convertibles that water leaks into the body through an opening at the quarter window belt. This condition can be corrected by cementing a closed-cell rubber seal on the lower end of the rear side rail.

Cut a seal from a piece of closed-cell rubber according to the dimensions on the accompanying sketch. Coat the inside and top surface of the seal with rubber cement. Also, apply

a coating of rubber cement to the lower, rear inside surface of the side rail weatherstrip and the lower end of the side rail. When the cement has dried tacky, press the seal firmly in place on the side rail. Repeat the operation on the opposite side.
