service reference book
session no. 105

POWERFLITE,

POWER STEERING

BRAKE SERVICE

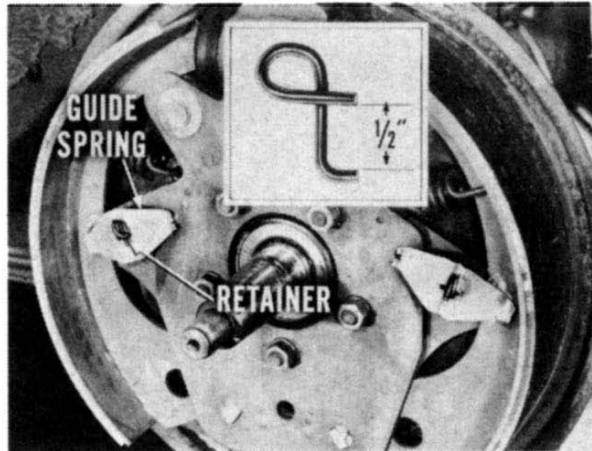
Check the two brake shoe guide springs. They hold the shoes steady, and cut down vibration, provided that they exert maximum tension against the shoe and support. Bend the springs to increase this tension, if necessary. Check the spring retainer, too; there should be about $\frac{1}{2}$ " between the two spring retainer prongs. Bend the prongs to get this distance, if needed.

Replace any warped shoes or support plates. Finally . . . button up the brake assemblies and road-test the job.
