SERVICE REFERENCE BOOK

of the MASTER TECHNICIANS SERVICE CONFERENCE

159

Steering and Suspension Service Tips

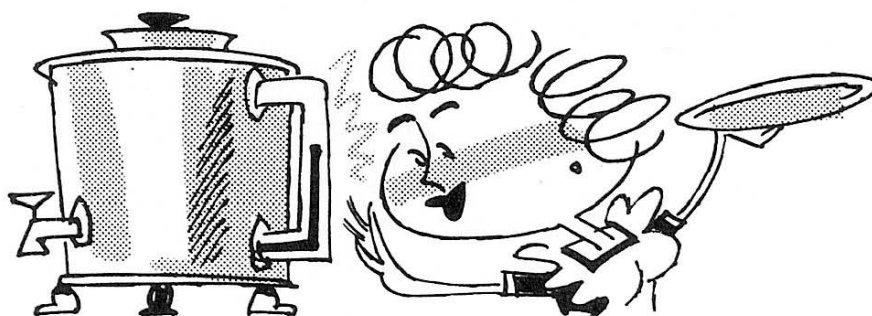
The first step in diagnosing a power steering gear complaint is to examine the fluid level, as outlined earlier. *Always* wipe off the filler neck and cap to prevent foreign matter from dropping into the reservoir when the cap is removed. Foreign matter circulating through the hydraulic system can cause considerable damage to internal parts.

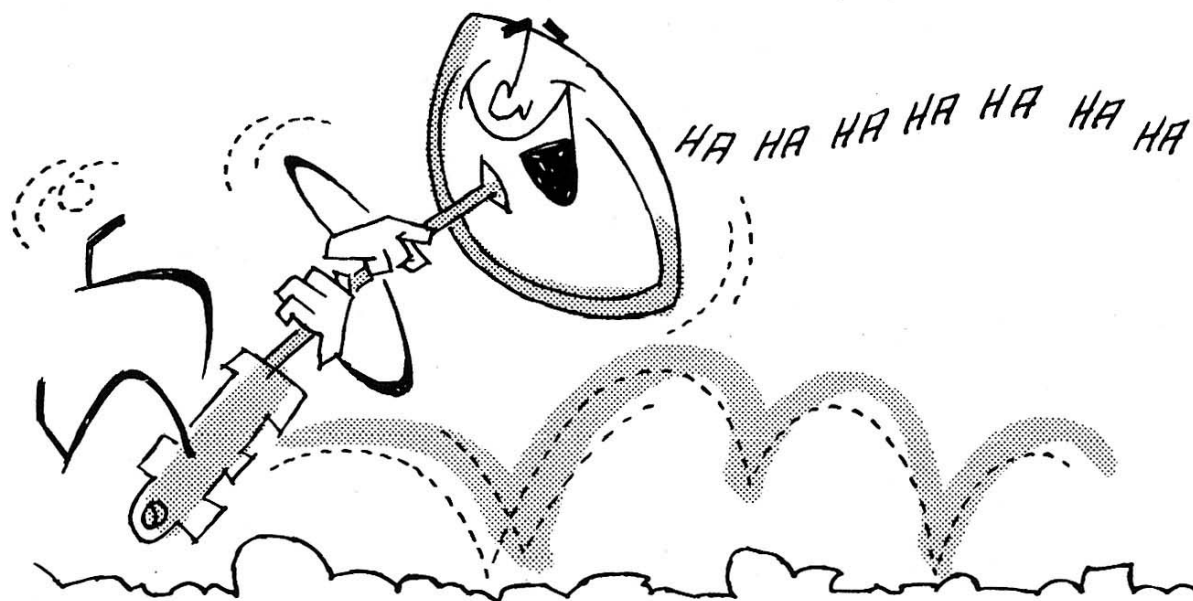
Chuckling Noise. There may be reports of a chuckling noise in the steering gear of a car equipped with power steering, when driving over railroad tracks or rough roads. The first item to examine would be the cross shaft adjustment. If the adjustment is satisfactory, or an adjustment does not afford relief, it is possible there is looseness in the steering gear coupling.

Looseness at this point can be determined by rocking the steering wheel and shaft in the housing. If there appears to be excessive movement, it is possible the rubber insulator and the plastic inserts in the insulator are damaged, or the insulator is undersize.

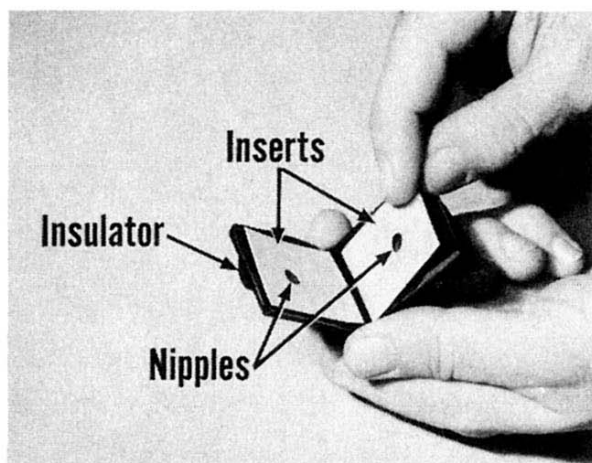
To correct this condition, remove the steering gear shaft and coupling from the gear. When installing new parts, be sure one insert is assembled on each side of the rubber insulator, and that the nipples on the insulator pass through the holes in the inserts to hold them in position in the insulator.

| Looseness in the coupling in power steering gears could be due to a damaged insulator and insulator inserts, or to an undersized insulator. | <input type="radio"/>

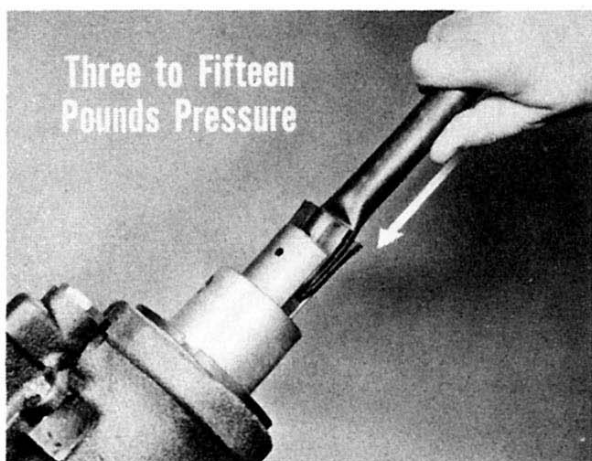
When these parts are assembled on the blade end of the steering tube, about three-to-fifteen pounds pressure should be required to push the parts into the coupling.

If less than the specified pressure is required to assemble the shaft in the coupling, the insulator might be slightly undersize. In that case, add another insert to one side. This will usually provide the proper thickness of the assembly to prevent looseness at this point.

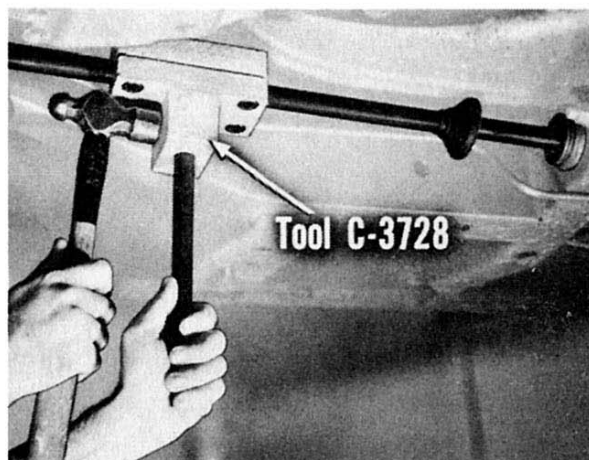
To remove the bar, place the two halves of the tool on the bar,

close to the front end of the bar, with the half provided with the striking pad on the bottom. Tighten the four socket-head-type screws evenly and securely to prevent the tool from slipping and scoring the bar. Hit the striking pad on the tool several sharp blows to loosen the bar from its anchors.

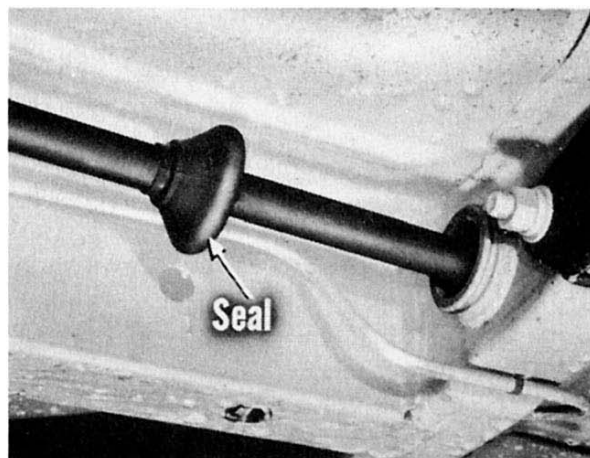
When installing the bar, the balloon-type seal must be placed on the bar with the cupped side to the rear. Coat both ends of the bar with multi-purpose grease.
