MASTER TECHNICIANS SERVICE CONFERENCE 66-7

CONVERTIBLE SERVICE

CHRYSLER
CORPORATION

This session concentrates on the 1966 Belvedere and Coronet convertibles, but Tech figures that once you get these models down pat, you won't have any trouble on any of the other models. There are some features on the 66's that you probably haven't seen before. For instance, all the normal top adjustment points are accessible without removing any interior trim panels. That's a big time and worksaver in itself. Then, there are a couple of new adjustments you'll want to know about. So, read through this book, and keep it handy to help you with convertible adjustments.

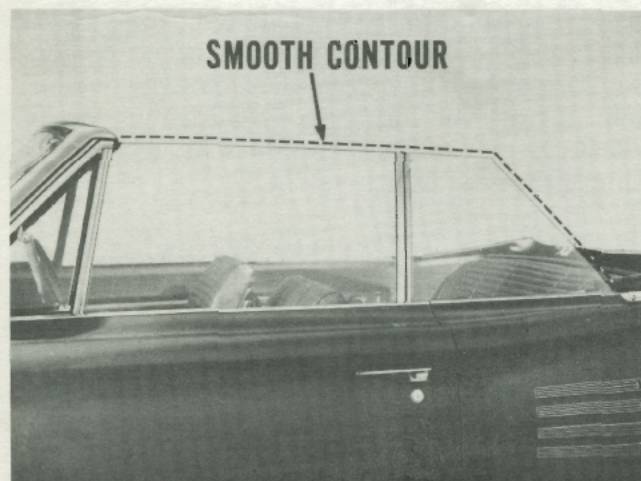
To have a good top-to-glass fit, it is necessary that the glass be properly aligned in the door and quarter panel. The vent wing, door glass and quarter glass should form a smooth contour from front to rear. So, the height of the glass and its forward-rearward attitude are of great importance.

Fig. 1—Good glass alignment is important

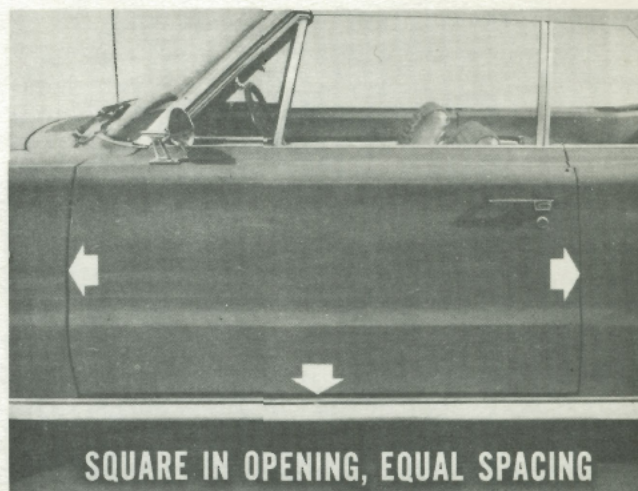
Always inspect the fit of the door before attempting any glass adjustment. You don't stand much chance of getting a good glass fit if the door is not square in the opening, with equal spacing at the front, rear and bottom.

Fig. 2—Always check door fit first

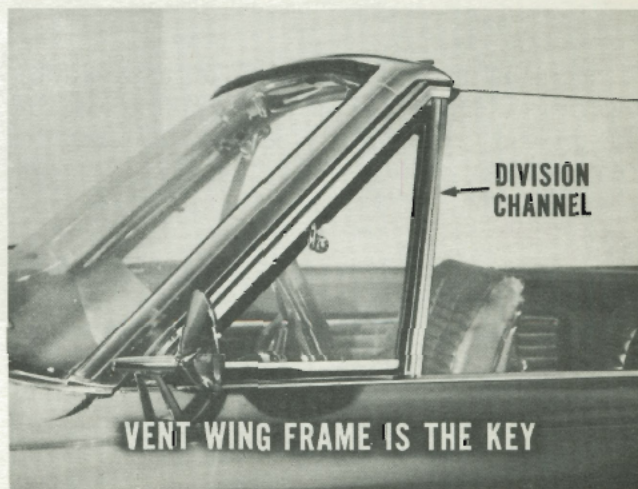
The only really solid point of reference for glass adjustments is the windshield pillar. So, the position of the vent wing frame in relation to the pillar is the key to good glass alignment. Because the vent wing frame and the door glass front track are one piece, a small amount of misalignment at the vent frame can cause a

Fig. 3—Glass alignment starts at vent wing

much greater amount of misalignment at the rear of the door glass. And, since the quarter glass position is largely dependent upon the positioning of the door glass, correct adjustment of the vent wing is doubly important.

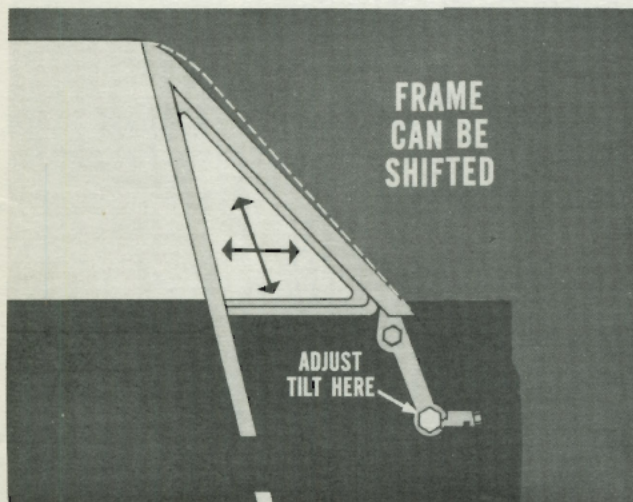
To check the position of the vent wing frame in relation to the windshield pillar, raise and latch the top. Then, see that the vent wing frame is parallel with the pillar, with equal spacing at the top and bottom. Also, check to see if the frame is high enough to contact the top side rail weatherstrip. If the frame is not parallel, or does not extend high enough, there is a provision for adjustment upward, downward, forward or rearward. You can also tilt the top of the vent frame in or out to make sure the frame and the front of the door glass seal laterally against the side rail weatherstrip.

Fig. 4—Vent wing frame adjustments

Inspect the in and out (tilt) adjustment by lowering the door glass and looking at the rear of the vent frame where it contacts the weatherstrip.

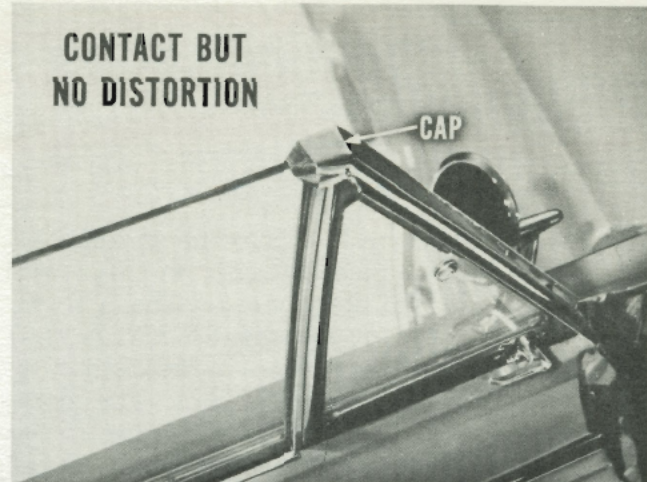
The up-stop adjustment is particularly important on the convertible door glass. If the glass does not go up high enough, it won't seal properly against the weatherstrip. If it goes too high, it could tear the top trim material when the door is opened or closed. Raise the glass until the front corner seals inside the cap at the top of the channel, but make sure the glass doesn't come up high enough to distort the cap.

Fig. 5—Correct up-stop setting

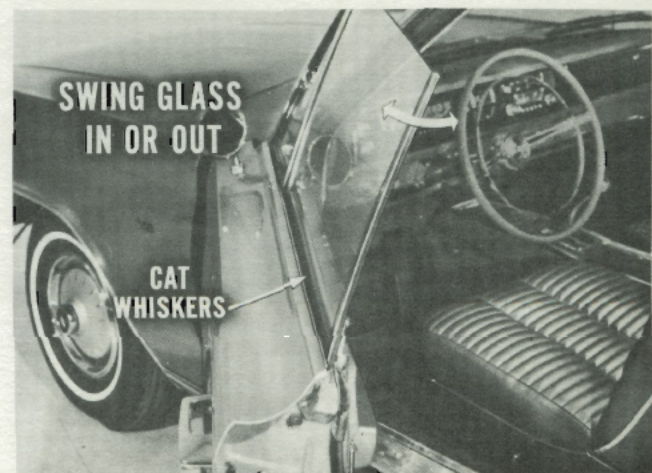
When the vent wing frame is set in against the weatherstrip, the front of the door glass is also in the correct sealing position. That's because the vent wing frame and the door glass division channel are one solid assembly. You may find it necessary to swing the rear of the door glass in or out to get good side rail weatherstrip contact at the top rear corner of the glass. If so, there are two in-and-out adjustment points, at the top and bottom of the rear track. Loosen both adjustments and move the glass in or out, as required. Make sure the glass is properly located in relation to the cat whiskers, at the belt line. The top edge of the glass should contact the outer lip of the weatherstrip, forcing it in against the inner lip. In addition, the inside face of the glass should seal against the inner lip of the weatherstrip.

Fig. 6—Rear track in and out

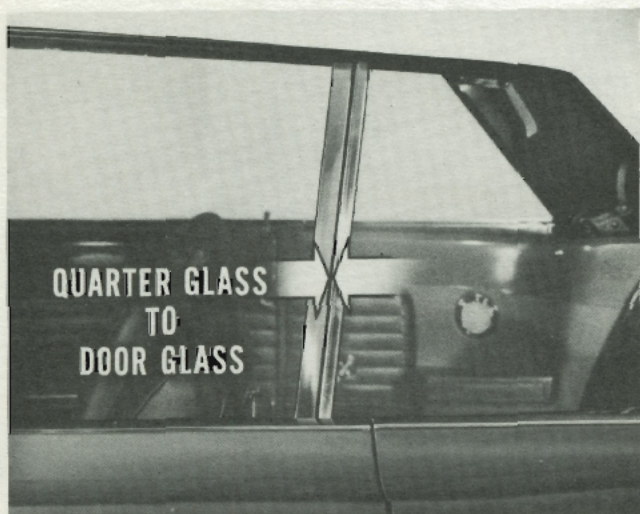
Correct quarter glass alignment is based on the proper alignment of the door glass. The edge frames of the two glasses should be parallel, and the door glass edge frame should seal against the weatherstrip on the quarter glass edge frame. If the two edge frames are not parallel, shift the pivot bracket to square up the glass in the opening.

Fig. 7—Edge frames must be parallel

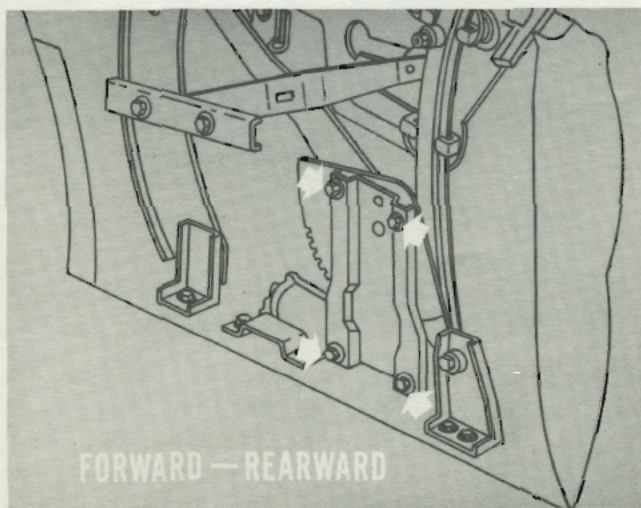
The quarter glass is also adjustable forward and rearward. The adjustment is made by shifting the regulator assembly. Make sure the quarter glass is far enough forward to provide

Fig. 8—Move regulator assembly

a good seal with the door glass, but not so far forward that the two edge frames interfere with the opening and closing of the door. You might have to work back and forth between the regulator assembly and the pivot bracket to get the best alignment.

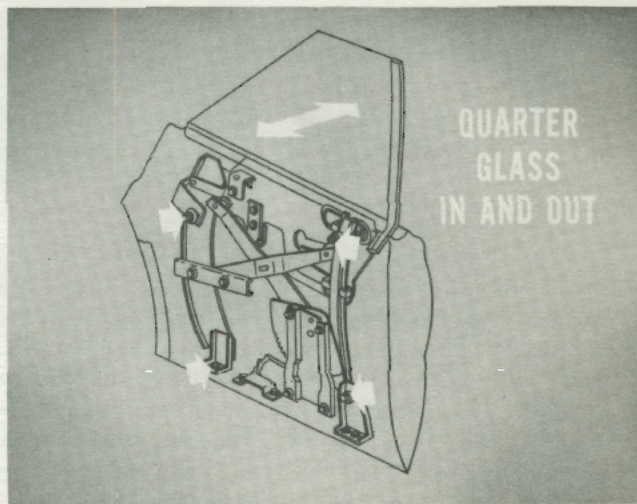
When properly adjusted, the quarter glass should lightly contact the cat whiskers at the belt line. The top of the stabilizer is adjustable in and out to provide this contact. Then, at the top of the front track, move the front of the quarter glass as necessary to align it with the rear of the door glass. Another in-out adjustment at the lower end of the track moves the top of the glass to align the top of the quarter glass and the door glass. If the door glass is properly adjusted at the top, then the quarter glass should seal against the side rail weatherstrip. To complete the in-out adjustments, loosen the stabilizer lower attaching screws and run the glass all the way down. This will position the stabilizer correctly. Then, tighten the lower attachment.

Fig. 9—Quarter glass adjustments

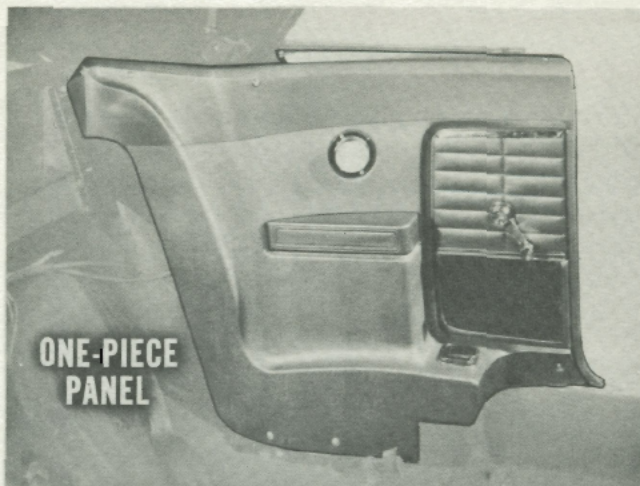
There's a new feature in these convertibles that simplifies the quarter glass adjustments. It's a combination garnish molding, trim panel and pocket panel, all in one piece, and attached with screws and three clips. Just remove the rear seat cushion and seat-back, and all the screws are readily accessible. But, if there are no adjustments necessary on the quarter glass, you won't have to remove the panel to make the adjustments to the folding top. All the normal adjustment points are accessible with the panel in place.

Fig. 10—New molded pocket panel

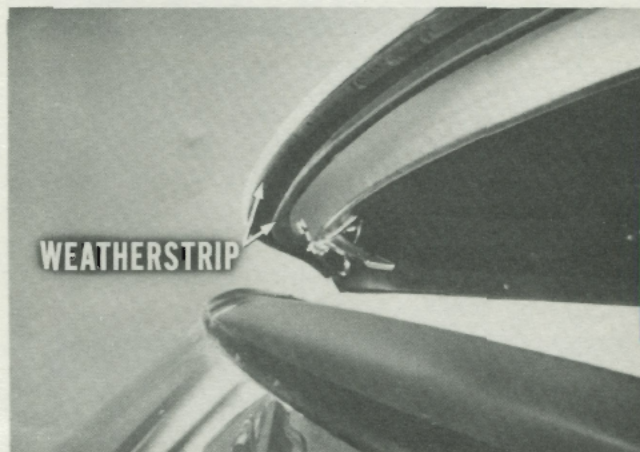
The latches on the 1966 Belvedere and Coronet have more leverage than those on previous models, so you can get the same sealing pressure as before with much less latching effort. That's something to keep in mind when you're adjusting the latches, since the amount of sealing pressure is important to the life of the header weatherstrip. If the latch hooks are too short, latching effort will be too high, and the weatherstrip will be over-compressed. The

Fig. 11—Latch hooks too short

weatherstrip will soon take a permanent set and lose its sealing ability. On the other hand, if the hooks are too long, there may be a leak at the weatherstrip.

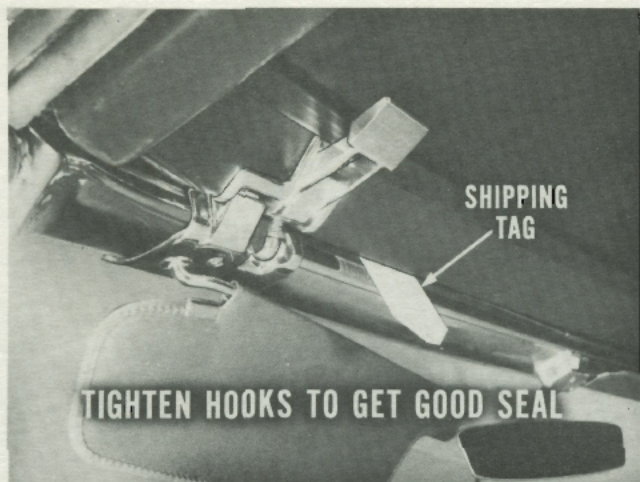
To determine whether there is sufficient sealing pressure at the header weatherstrip, latch the top with a piece of heavy paper or a card between the header. (A shipping tag is just the right thickness.) The header weatherstrip

Fig. 12—Check the sealing pressure

should grip the card lightly when it's pulled out. If the seal is too loose, tighten the latching hooks one turn at a time until the correct pressure is obtained. Check the seal all the way across the header. If the seal is good on the ends of the header, but loose in the middle, you might have to place a thin shim under the weatherstrip. Always water-test the header area after adjusting the hooks to make sure there is no leak.

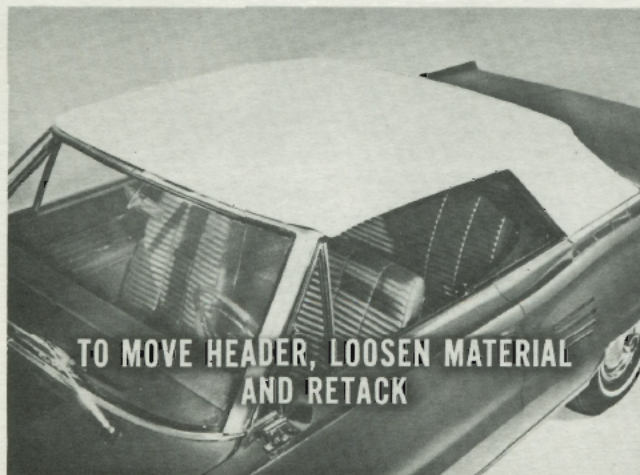
This is one adjustment that you shouldn't have to use except in cases of extreme misalignment of the header locating dowels. In fact, you should use this adjustment only if the other header locating adjustments do not provide enough movement forward or rearward. The other adjustments will be discussed later, in another section.

Fig. 13—Header to side rail adjustment

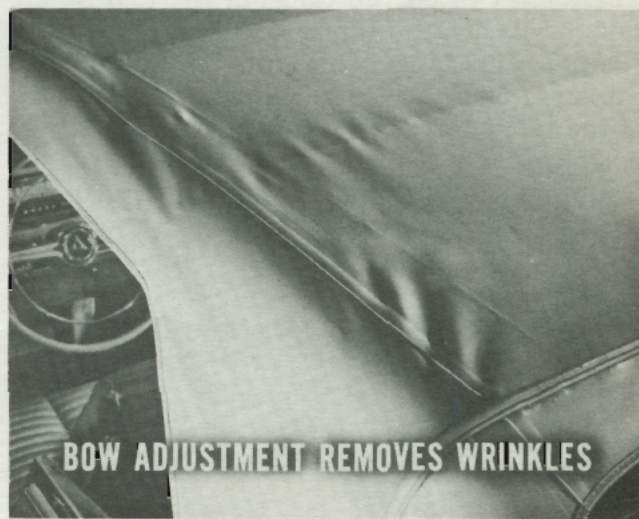
One of the new adjustments built into the 1966 convertibles is at the number one and number two roof bows. The bows have slotted attaching holes to provide a small amount of vertical movement. This allows some adjustment of the top material tension if a header adjustment loosens the material. Also, if there are any wrinkles in the material, the bow adjustments can be used to remove them. You might have to move one side of the bow a little bit more than the other to get rid of some of the wrinkles.

Fig. 14—New adjustable roof bows

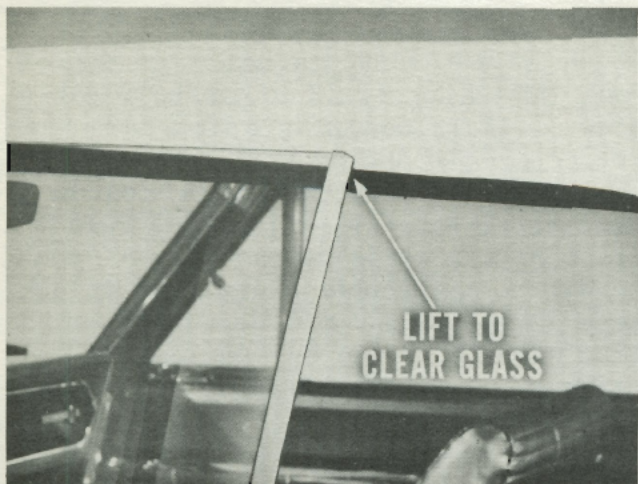
Another function of the roof bow alignment, and possibly the most important of all, is to lift the side of the top material clear of the door glass. If the material is too low at this point, it could be torn by the top of the glass when the door is opened or closed.

Fig. 15—Door glass could tear the top material

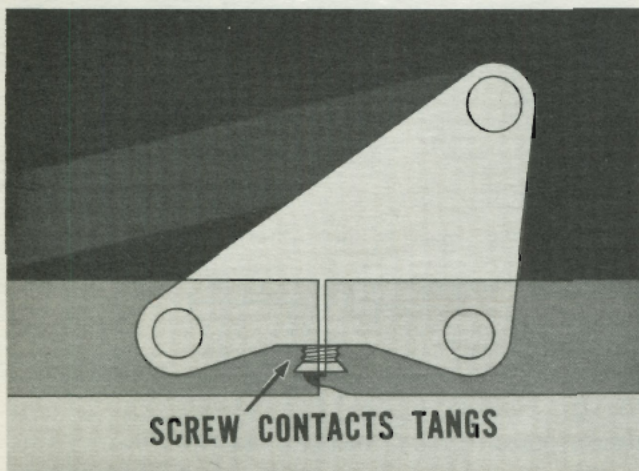
There are two curved tangs at the rear of the side rail. When the top is raised and latched in position, the tangs slide into the center side rail and under the center joint screw. The head of the screw forces the tangs down against the bottom of the center side rail to line up the front and center rails. If the screw is turned in too far, the tangs will not be against the center rail, and the two rails will not be in alignment.

Fig. 16—Center joint screw determines height

In addition to being misaligned, the rails will raise up at the center joint, causing a "jackknife" condition.

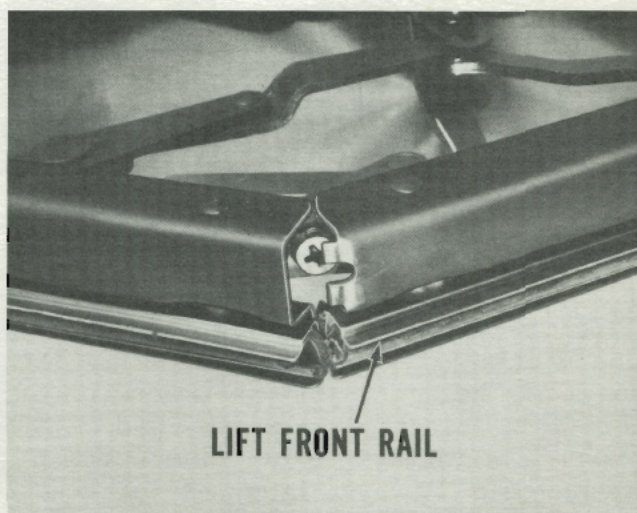
To correct a "jackknife" condition at the center joint, unlatch the top header and raise the front of the front side rail to open the joint.

Fig. 17—Center joint adjustment screw

Then, back the screw out just far enough to force the joint down into position. If the door glass is correctly positioned, the side rail weatherstrip should contact the top of the glass as described earlier. There's another way you can check the center joint position. Place a straightedge against the side rails between the rear of the header bracket and the rear of the center rail. The center joint should be

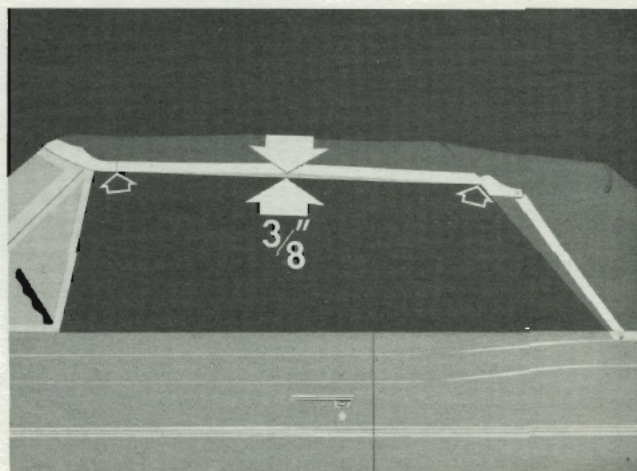
Fig. 18—Checking center joint height

about $\frac{3}{8}$ -inch above the straightedge. (If you don't have a straightedge that long, a piece of string will do the job.) Just don't back the screw out too far. If you do, the head of the screw might bend the tangs, or distort the bottom of the center side rail.

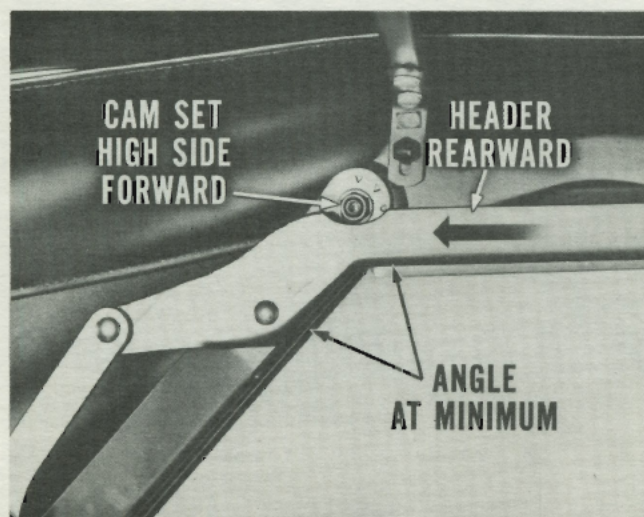
There's another new adjustment on the 1966 convertibles, at the top of the rear side rail. It's a cam assembly, and it's used to change the position of the top header in relation to the windshield header. The cam turns inside the rear side rail and the thrust link, which is part of the operating linkage. When the cam is rotated, it changes the relationship between the front and rear side rails, by moving the thrust link forward or rearward.

Fig. 19—Cam changes header position

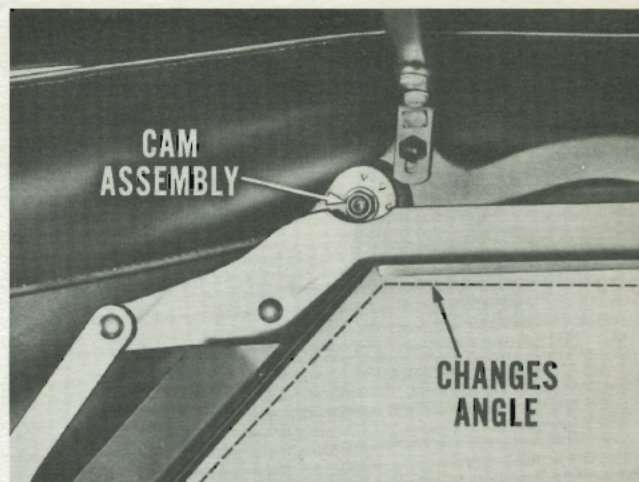
Usually, when the top is originally trimmed, the cam is set with the high side forward. Oddly enough, this means that the header is as far rearward as the cam can position it. When the cam is rotated to the rear, in effect, it moves the top header forward on the windshield header. Let's take a look at what actually happens.

Fig. 20—Cam set forward brings header rearward

The position of the high side of the cam determines the angle between the center side rail and the rear side rail. When the high side is all the way forward, the angle is at the minimum. As the high side of the cam is turned toward the rear, the angle is increased. The increased angle also increases the forward "throw" of the entire top assembly. So, when the top is raised, the top header is farther forward on the windshield header.

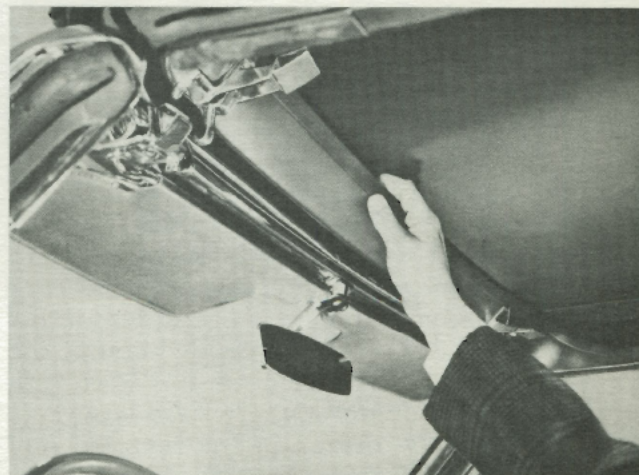
When the center-to-rear side rail angle is increased by adjusting the cam, the top header settles higher off the windshield header. This means that the latching effort will be increased slightly. However, even with this slight increase, the overall effort of engaging the top

Fig. 21—Easier to pull than to push

header dowels with the holes in the windshield header is somewhat less. That's because it is much easier to pull the header straight down, or even back slightly, than it is to push it forward and then down.

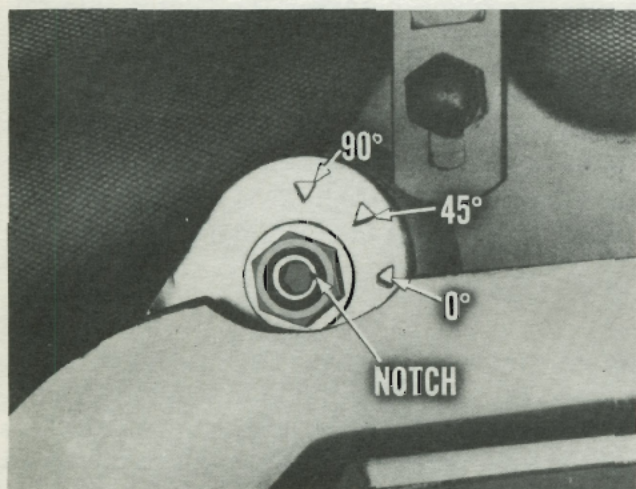
The high side of the cam is indicated by a notch in the threaded end of the cam. Three triangular-shaped marks on the side rail indicate the amount of rotation of the cam when you're making an adjustment. The marks are located at the full-forward position of the high side, 45 degrees up, and 90 degrees up. By referring to the notch and the three triangular marks, you can always tell where the high side of the cam is and, when adjusting the cams, you can be sure just how much adjustment is being made on each cam.

Fig. 22—Cam location marks

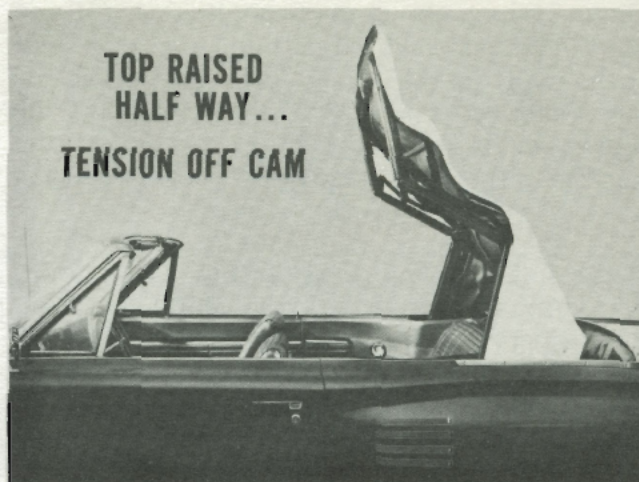
Before you attempt any adjustment of the center-to-rear rail cam, always place the top in the *intermediate position*. (Halfway between the raised and lowered positions.) This will take much of the strain off the cam. Make sure the lock nut is loose, and tap the threaded end of the cam with a soft-faced hammer to break loose any paint bond between the cam and the top linkage. There's a good reason for all these precautions. The threaded end of the cam, with the hex socket head, has to have a small outside diameter. Otherwise, a large hole would have to be drilled in the rear rail and thrust link, reducing the strength. And, the hex must be large enough to provide the leverage

Fig. 23—Makes cam easier to turn

to turn the cam. So, we wind up with a comparatively thin wall around the hex socket. If the cam is bound up in any way, it's possible that the wall would be split out when you're trying to turn the cam.

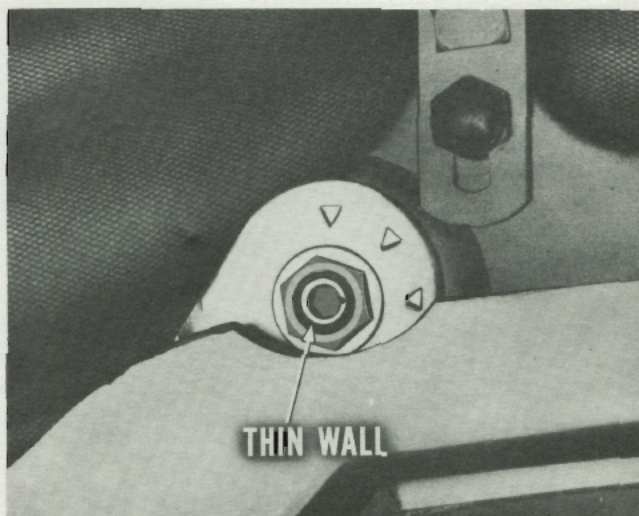
Fig. 24—Be careful not to split socket

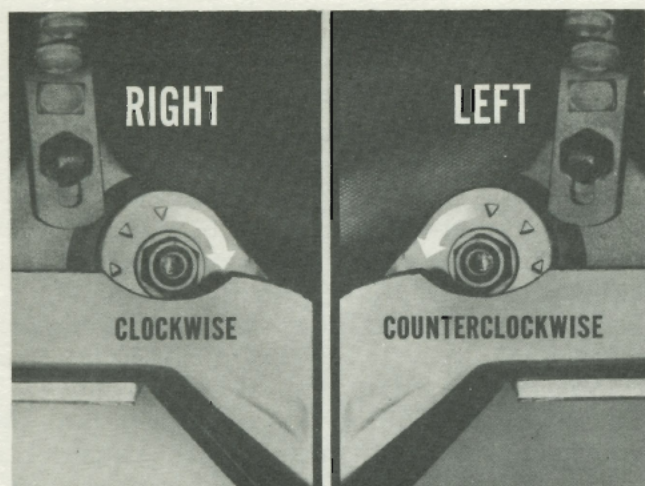
The cams can be turned in either direction to make the header adjustment. However, it's best to turn them upward. That means that the left cam should be turned in a counter-clockwise direction, and the right cam in a clockwise direction. In most cases, it's a good idea to make sure the cams are turned the same amount, as well as in the same direction. But, there may be times when it's necessary to turn one cam more than the other, if one side of the header is farther forward than the other.

Fig. 25—Best way to turn cams

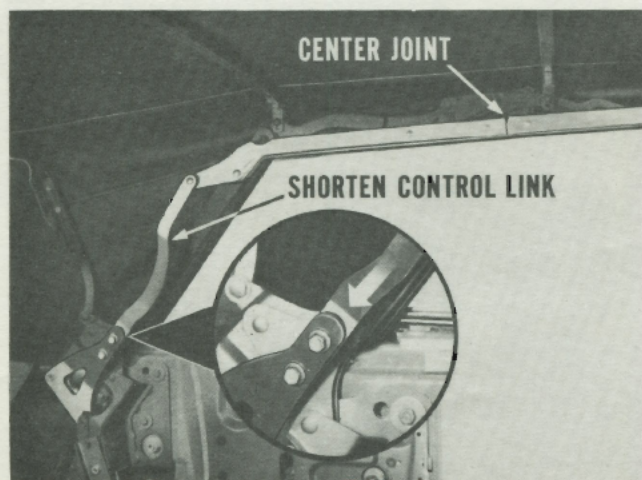
If the required cam adjustment is fairly large, it's possible to develop a sagging condition at the center joint, between the front and center side rails. This condition cannot be corrected by adjusting the center joint screw. Instead, the center joint is lifted into the correct position by shortening the control link at the rear of the folding top operating linkage. Shortening the link pulls down on the rear of the center side rail, lifting the front of the center rail and the rear of the front rail. Usually, one or two serrations change at the control link adjustment point are all that will be required.

Fig. 26—Correcting side-rail sag

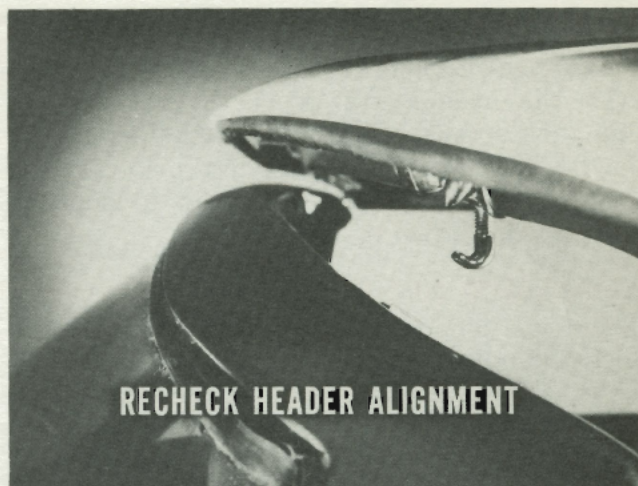
Fig. 27—May have to readjust cam

header. As you can see in the illustration, shortening the control link increases the angle at the center rail to rear rail joint. So, the overall reach of the top linkage is increased, just as it is when the cam adjustment is turned to the rear. This means that you may have to work back and forth between the cam and the control link to get the correct header adjustment and still have the preferred contour at the center joint.

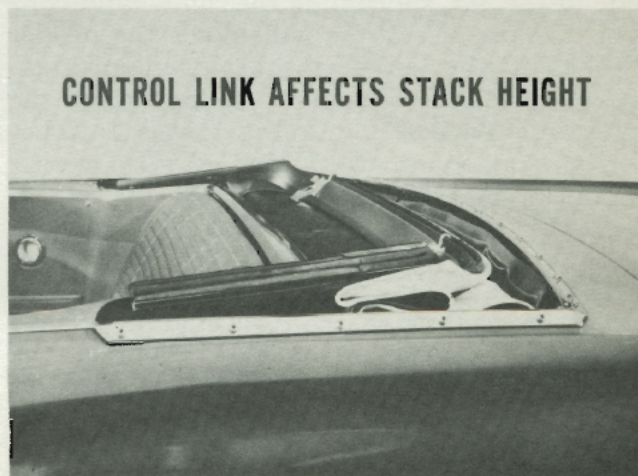
The length of the control link also affects the stack height of the top linkage when it is lowered into the boot well. If the linkage does not enter the well far enough, it will be very difficult to install the boot. To lower the stack height, lengthen the control link one or two serrations. Then, recheck header alignment.

Fig. 28—Lengthen link to lower stack height

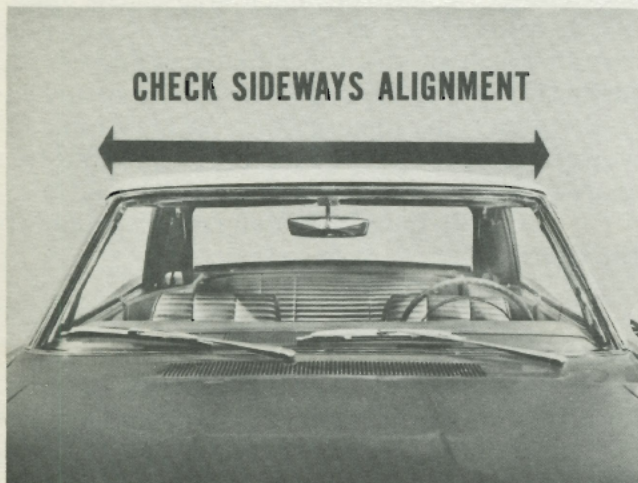
The dowel pins in the top header must line up with the holes in the windshield header sideways, as well as forward and rearward. Any great amount of sideways misalignment will have as much effect on the latching effort as if the header were too far to the rear. If the dowels do not line up properly, you can shift the front of the top assembly sideways a small amount by lengthening or shortening one control link.

Fig. 29—Dowels must line up sideways, too

For instance, if the header is off to the right side of the car, shortening the right-hand control link one serration will move the header $\frac{1}{8}$ -inch to the left. If more movement than this is required, you might have to pivot the mounting plate to line up the dowels. But, before you do, be sure to read the section covering mounting plate adjustments.

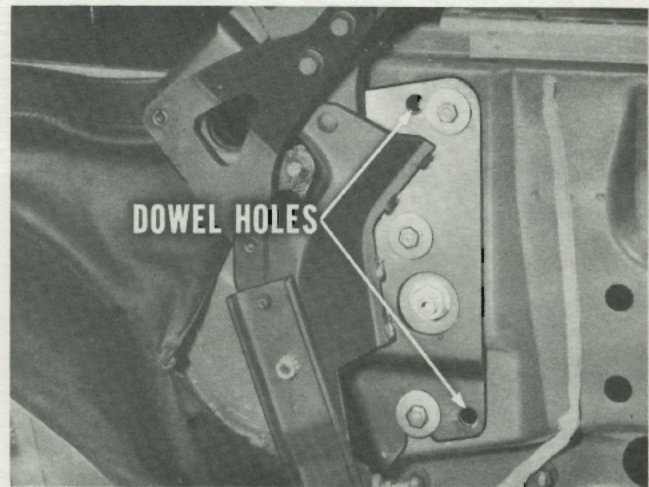
Ordinarily, the mounting plate should not be moved. You'll notice two alignment dowel holes in the plate and the body inner panel. These holes are used to get the basic alignment when the top assembly is installed. But, even if the holes are not exactly aligned, don't be in a big hurry to move the plate. It might have needed a little bit of shifting around to compensate for those little variations between cars that occur during manufacturing. So, if you have to remove the whole top assembly for any reason, such as collision repairs, just keep in mind that those two extra holes are there for reasons of alignment only.

Fig. 30—Mounting plate not moved normally

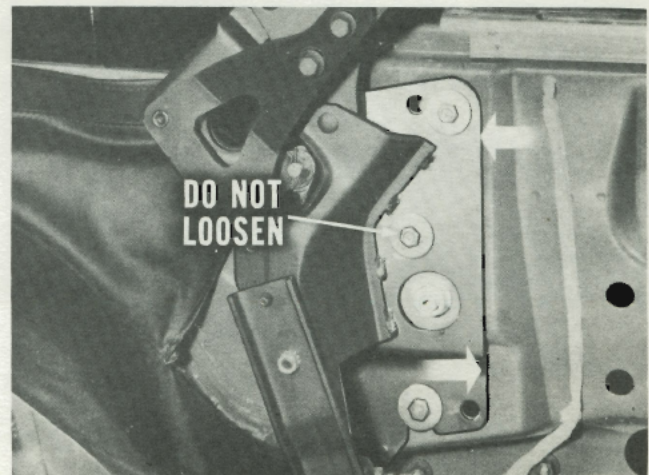
Fig. 31—Pivot plate around center screw

If you should find it necessary to use the mounting plate to correct a sideways misalignment condition, **DO NOT** loosen all the mounting plate attaching screws. Loosen **ONLY** the top and bottom screws. Then, pivot the mounting plate around the center screw to get enough movement to align the header dowels, and retighten the top and bottom screws. After making this mounting plate adjustment, be sure to go back and check all the other alignment conditions, including the side glass-to-side rail weatherstrip contact.

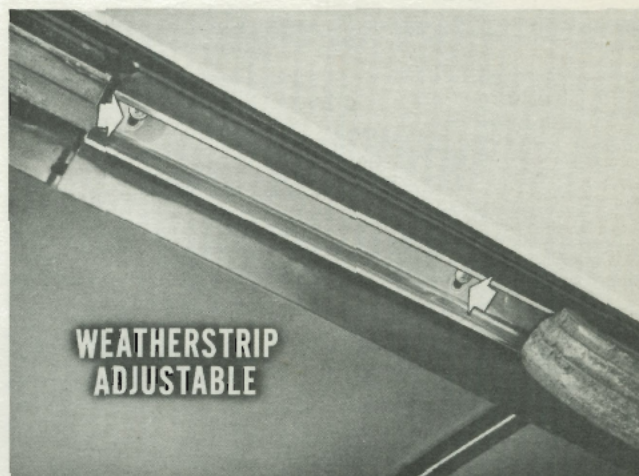
You might find that the weatherstrip seals against the side glass at the front, but not at the rear, or that a section in the middle of the glass does not seal properly, even though the door and quarter glasses are correctly aligned. If you do, there's a small amount of in-and-out adjustment available at the weatherstrip itself. The weatherstrip retainer strip is attached to the side rails by screws, with elongated screw

holes in the retainer. To make the in-or-out adjustment, drop the weatherstrip from the retainer, loosen the attaching screws and move the retainer strip as necessary. You'll probably want to cement the ends of the weatherstrip in place when you re-install it.

Fig. 32—Weatherstrip retainer is movable

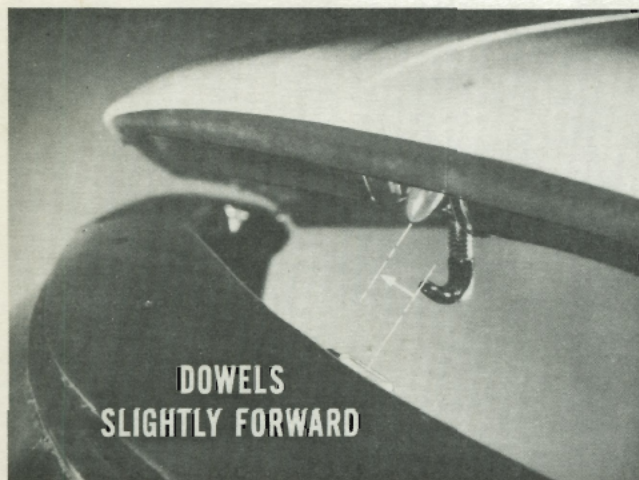
When you're ready to install the top trim material, make sure the cam adjustment is set so the high side of the cam is all the way forward. Remember, this is the most rearward header position available at the cam adjustment.

Fig. 34—Set dowels forward when retrimming

Then set the control links by loosening the lock screws and lifting the header about ten inches off the windshield header. (Lift the header by raising the front of the center side rail.) Tighten the control link lock screws and check the forward-rearward position of the top header. Before installing the material, use the header-to-side rail adjustment to set the top header dowels about $\frac{1}{4}$ -inch ahead of the dowel holes in the windshield header. The tension of the top materials should pull the header back into the correct position, so the dowels will line up with the holes.

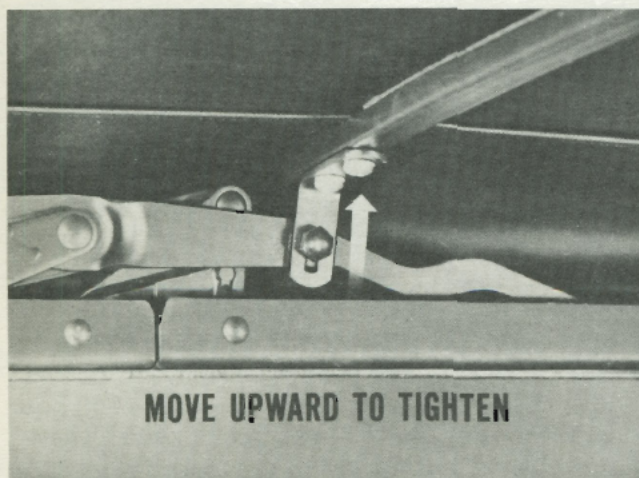
Fig. 35—Set bows down when retrimming

Another preliminary step when retrimming a top is to set the number one and number two roof bows in their lowest positions. This will provide ample adjustment of the top material, if it's necessary to increase the tension. The tension is especially important, to avoid any "ballooning" appearance at road speeds. Remember, too, that you may have to use the roof bow adjustment to lift the sides of the top material clear of the door glass to avoid tearing the material when the door is opened or closed.

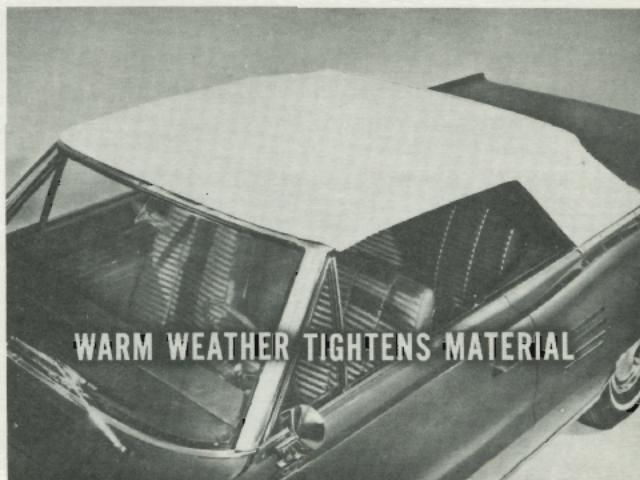
The temperature of the top material when it's installed can have quite an effect on top fit and material tension, especially in areas where there is a large variation in weather. If the top is trimmed in cold weather, the material may tighten up when the weather gets warm. So, in areas with extreme weather changes, it might be desirable to re-adjust the tension a couple of times a year.

Fig. 36—Temperature affects material tension

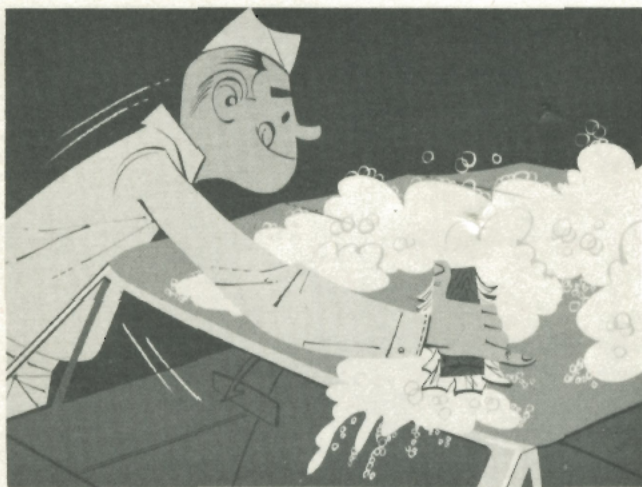
Top material is a little bit like a suit of clothes: if you keep it clean, it will last a lot longer and look much better. Your customers should know that a good working over with a vacuum cleaner will help to keep abrasive dust from collecting in the folds and seams of the material. And, frequent washing, if properly done, will add to top life and appearance. Use a soft hand brush with natural bristles, and a bar of ordinary laundry soap. Place some kind of support under the material and scrub an area of about two feet at a time. Do not scrub hard on the seams. Rinse with clear water, and use plenty of it to make sure all the soap and dirt are rinsed out of the material. Otherwise, the material might become stained when it dries out. And, speaking of drying, the top should never be lowered when the material is wet, or even slightly damp.

Fig. 37—Clean top material often

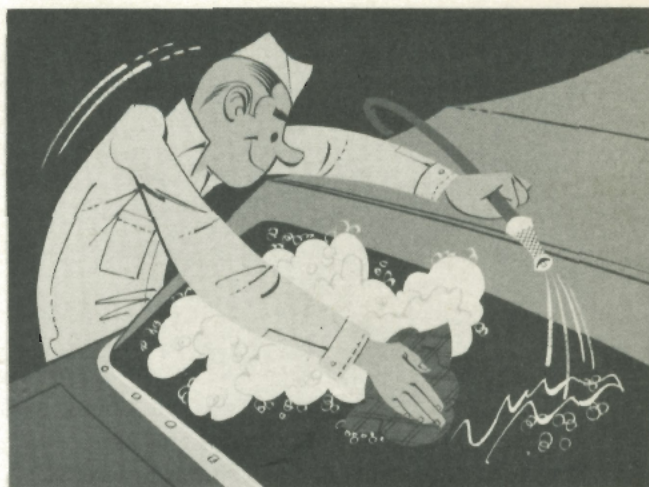
Fig. 38—Clean rear window carefully

Do wash the rear window with a soft cloth and household detergent, using a heavy lather. Rinse with plenty of clear water and wipe with a slightly moistened clean cloth. To remove plain road dust, use a soft, clean cloth moistened with clear water only.
